Heavy rain and flood affected areas in Coastal Region, Andhra Pradesh State

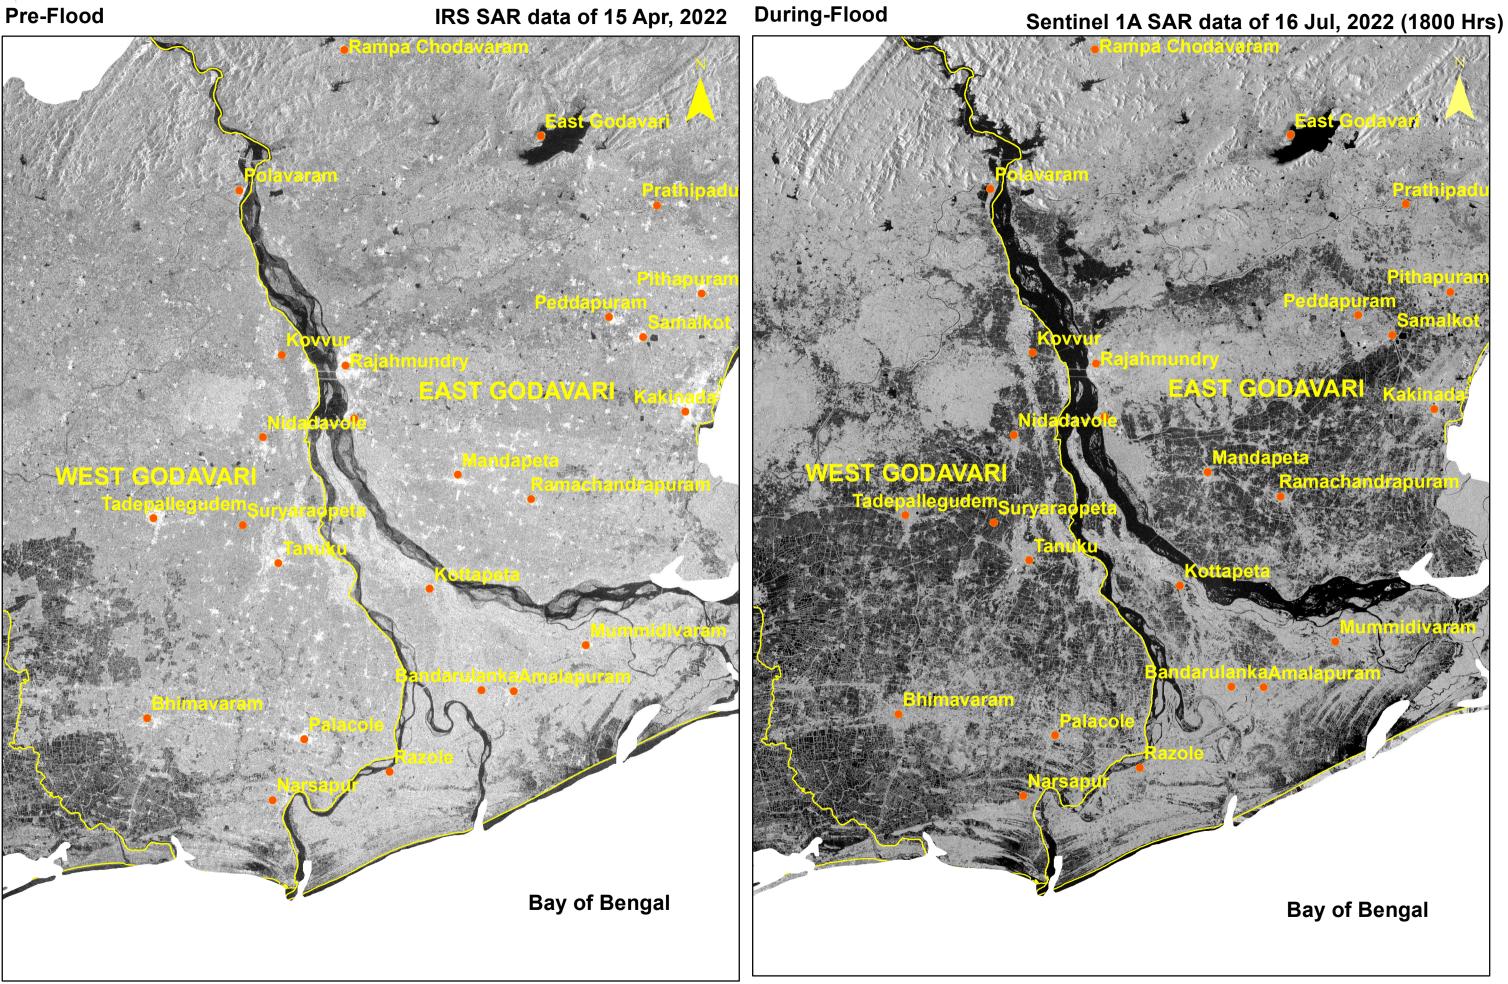
Note: The dark pixels/ patches seen in the satellite image of Sentinel 1A SAR of 16 July 2022 may represent areas under rain water accumulation / flood water in low lying areas / salt panes/ aquaculture. Flooding beneath the vegetation can be seen partially.
