# Chungthang Dam and Surroundings

Lachen River Reach nearer to Chungthang Dam

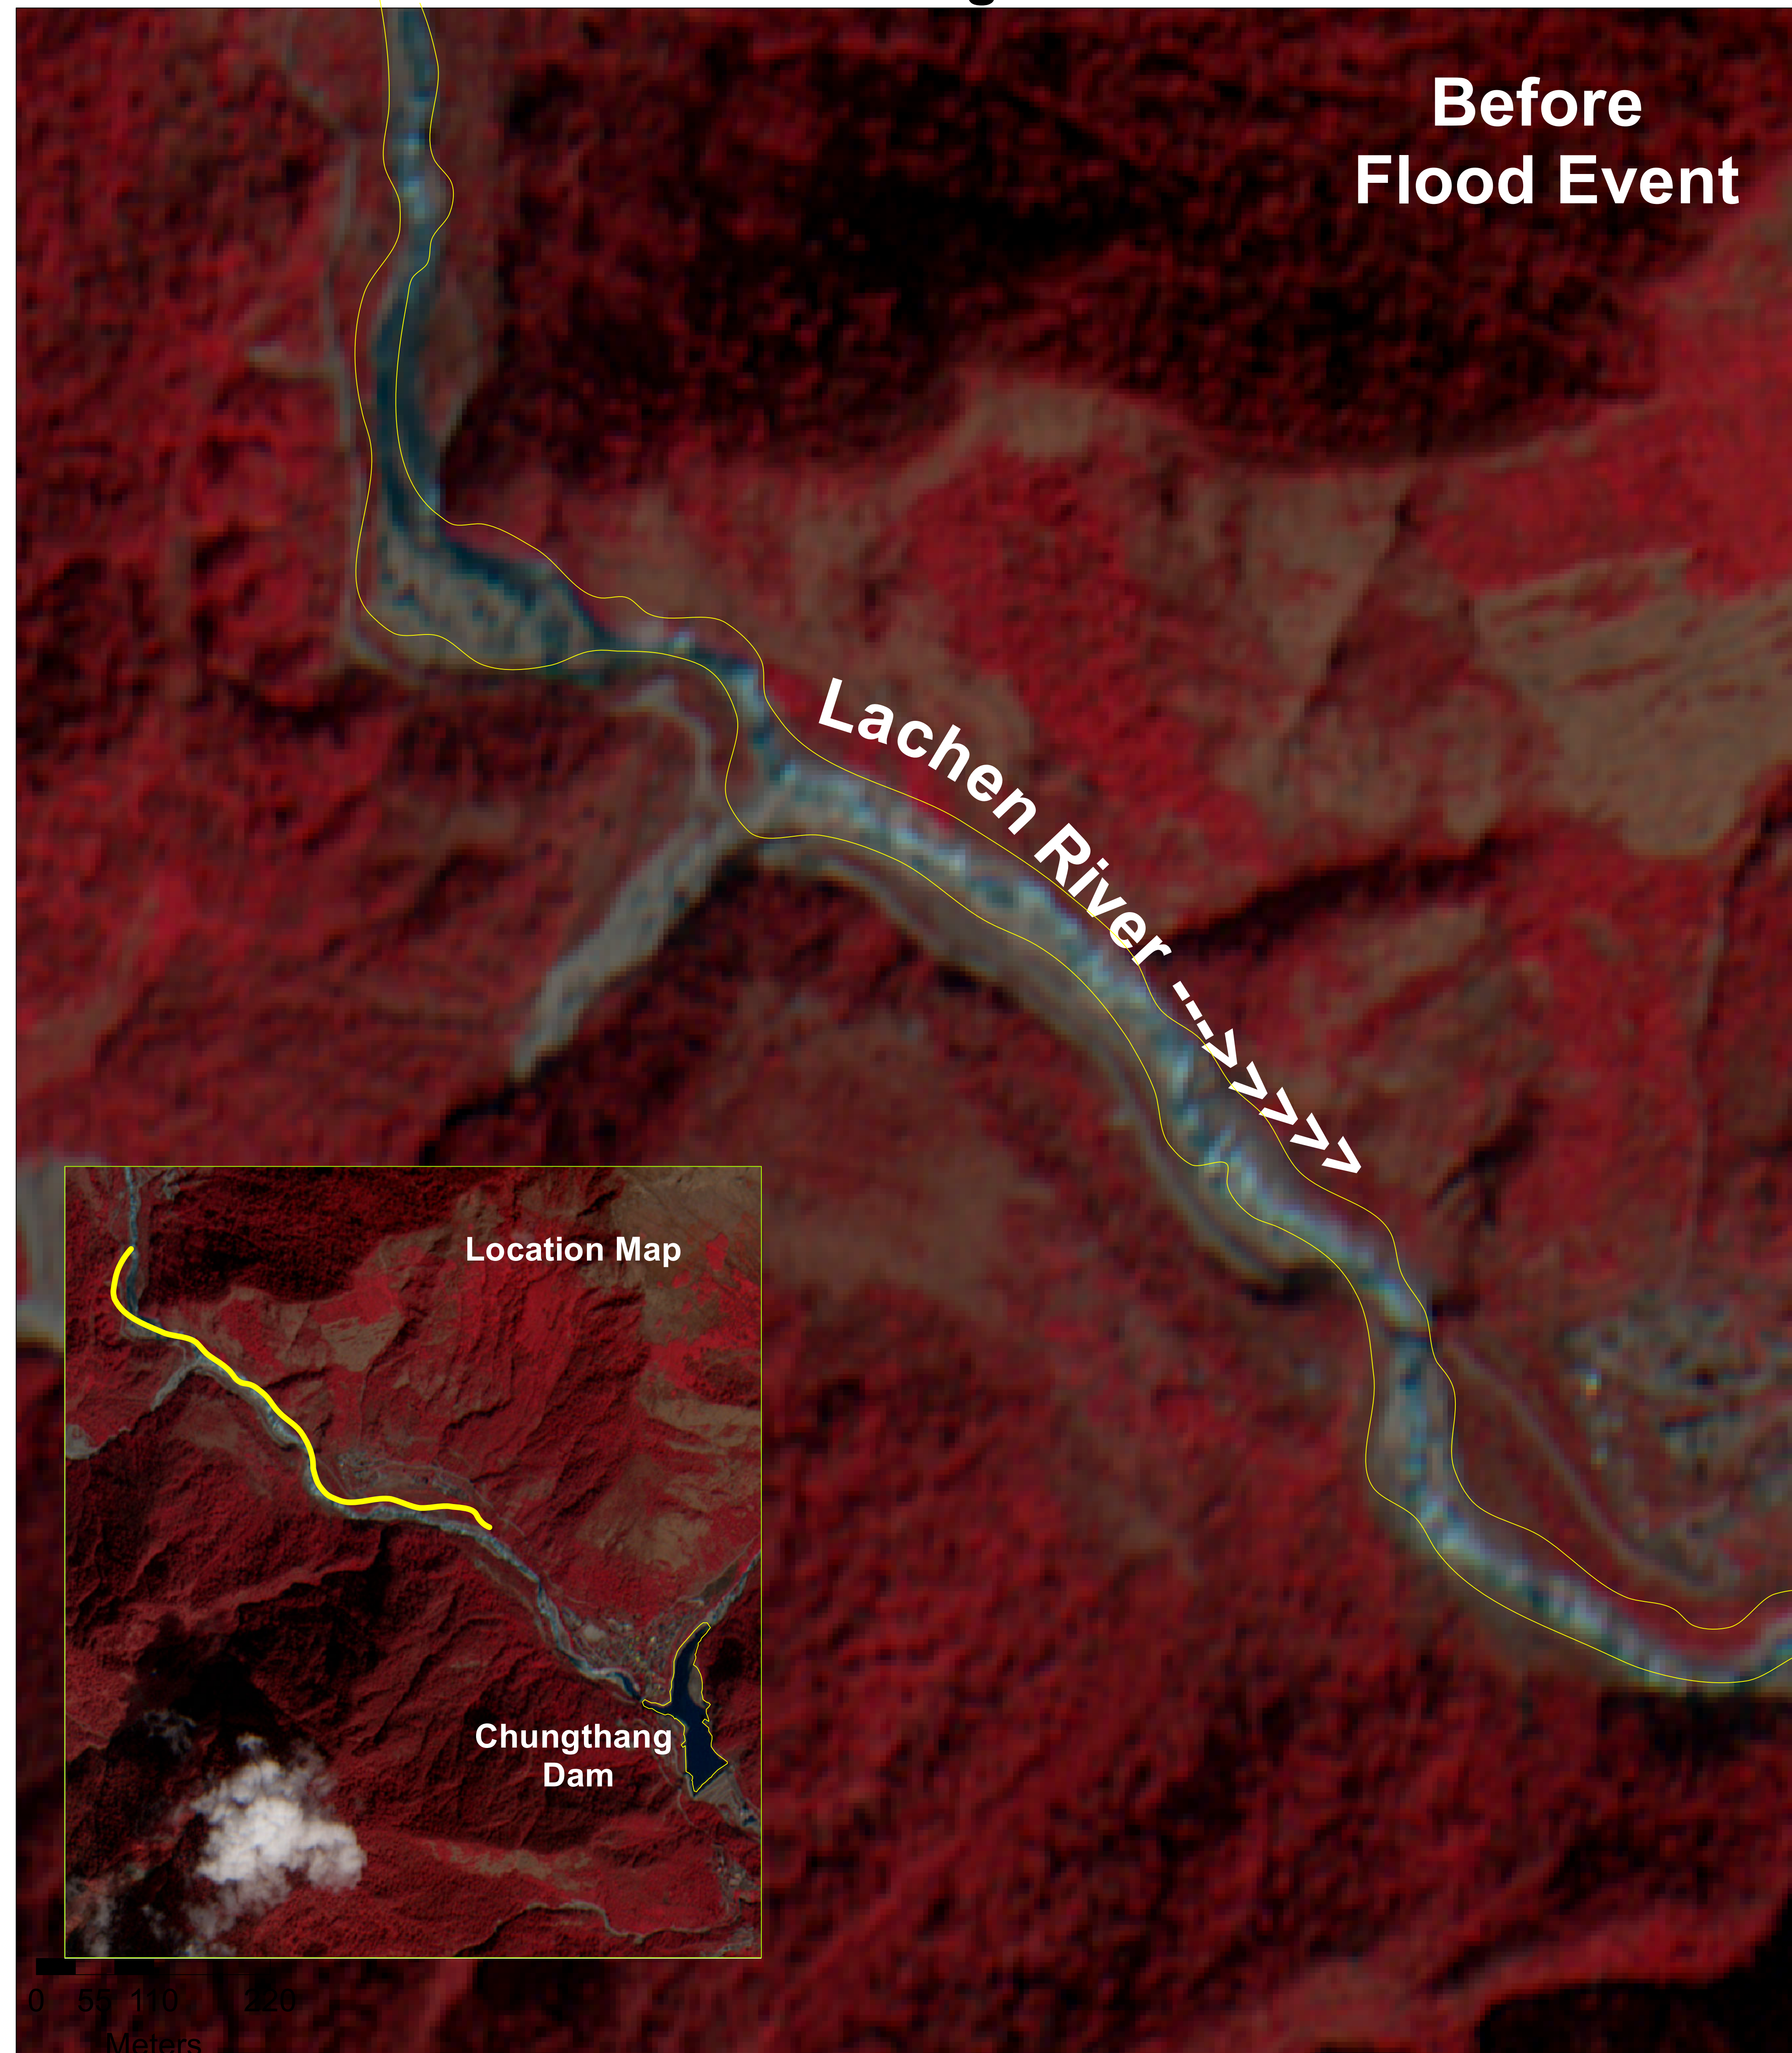
Resourcesat-2A LISS-IV Satellite Image of 03 Mar 2023

Comparison of Pre and Post flood event satellite images indicate that there are River morphological changes due to huge sediment deposition in Lachen River reach which is nearer to Chungthang Dam
