## Earthquake in Myanmar.

### Earthquake Impact Map of Mandalay City

Observed on 29/03/2025

AOI No.01

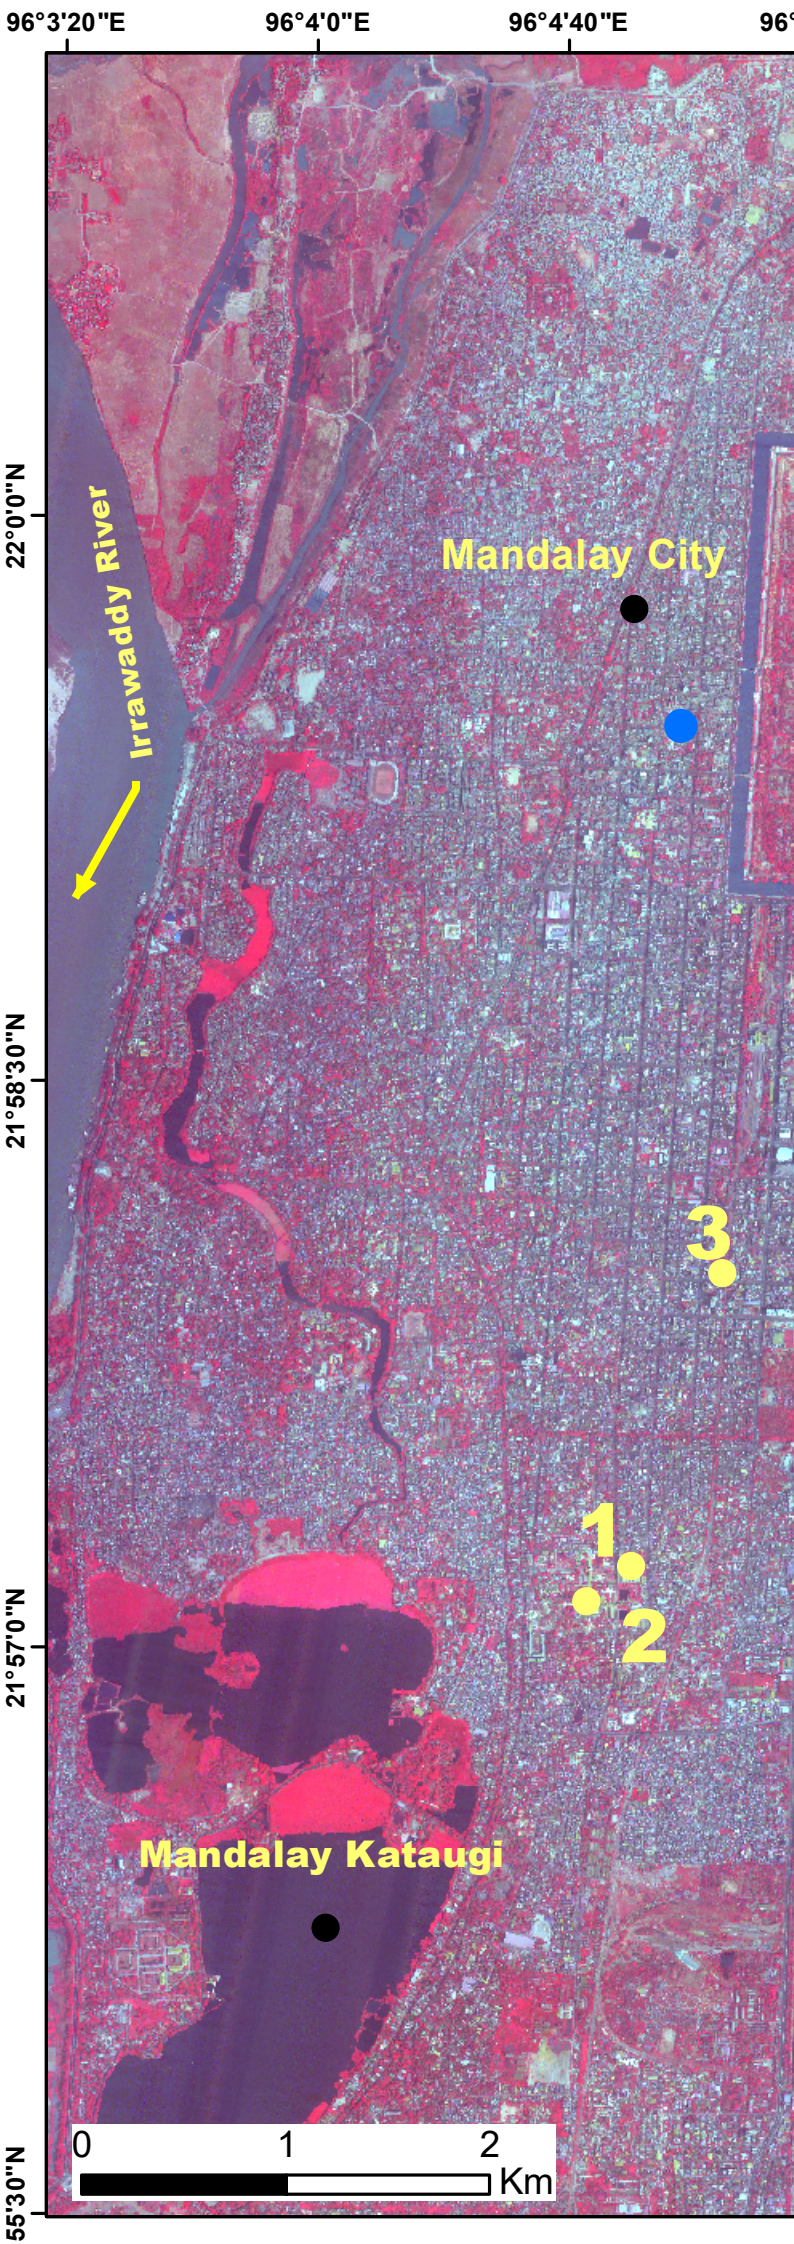
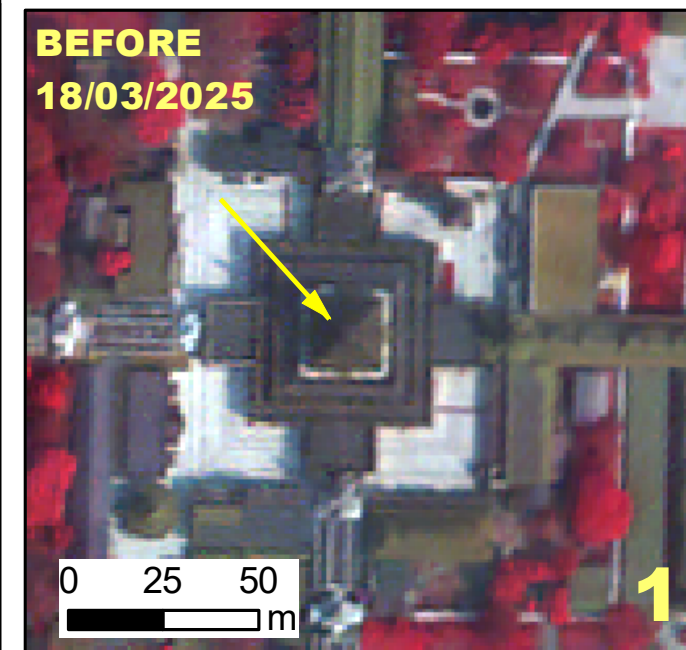
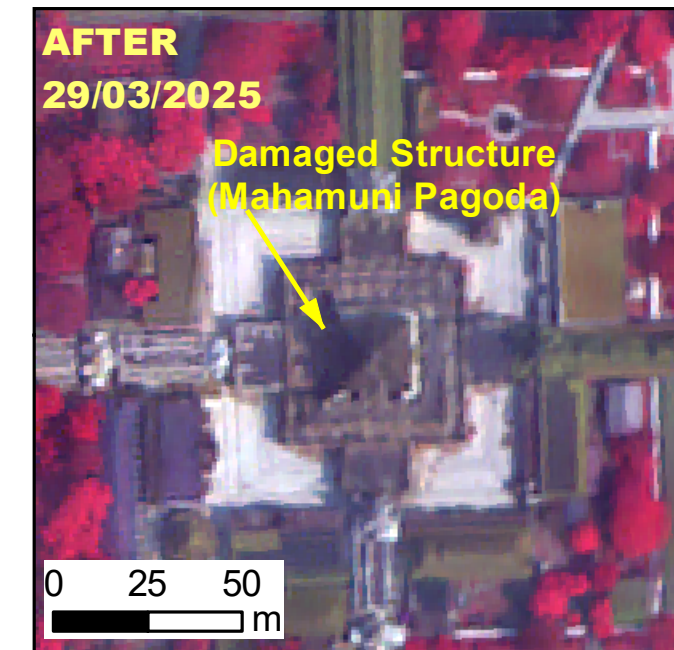
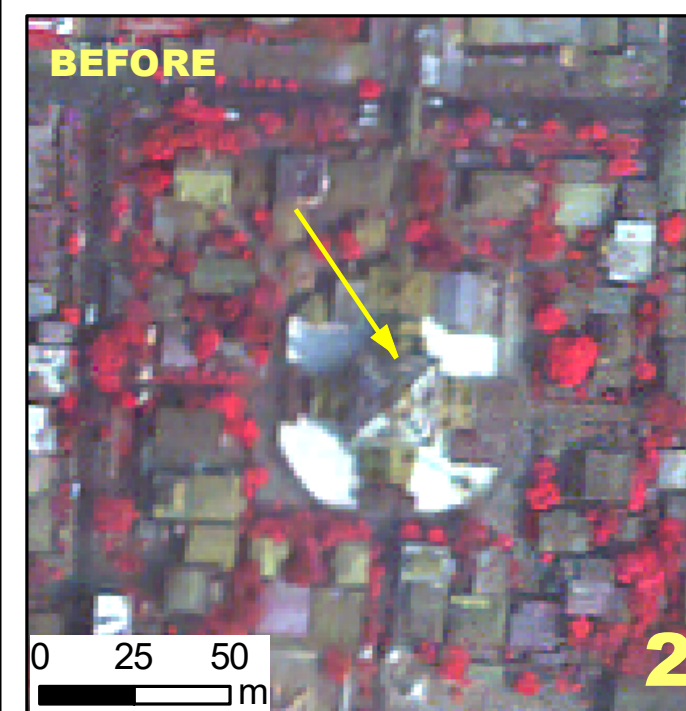
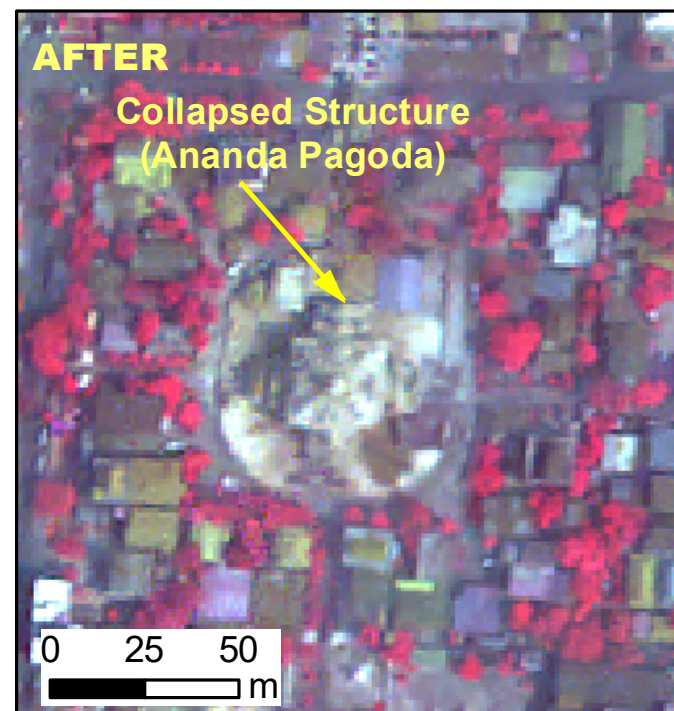
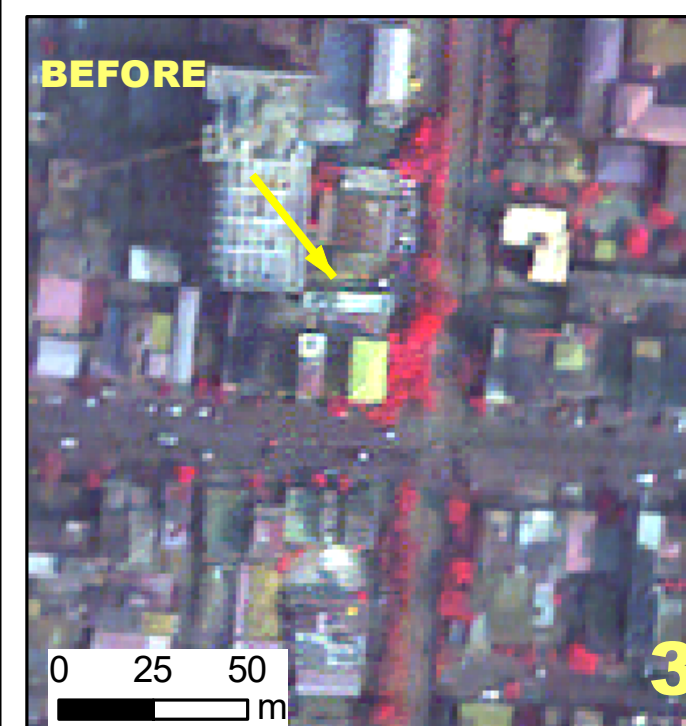
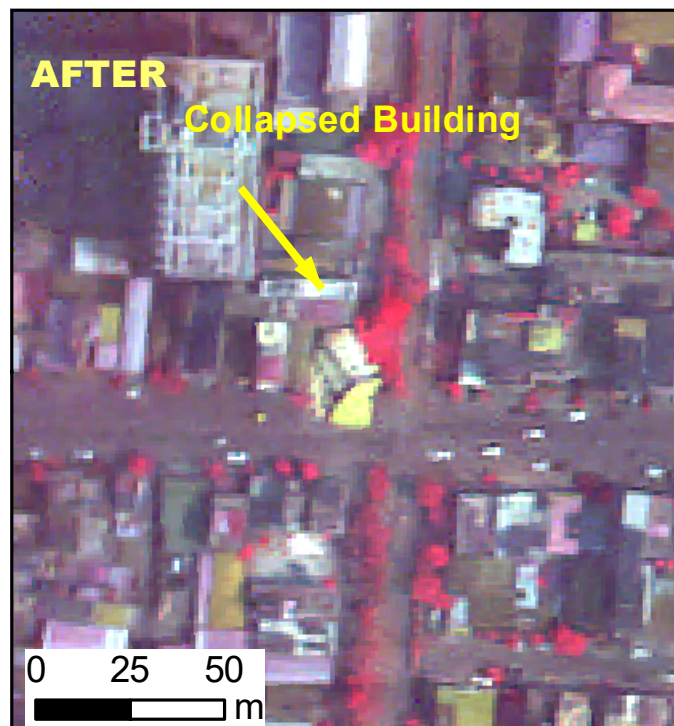
● Fully damage ● Partial damage

An earthquake of magnitude 7.7 struck near Sagaing, Myanmar on 28th march 2025 06:20:54 (UTC) followed by atleast three strong aftershocks. The tremors was also felt intensively in India, Bangladesh, Laos, Thailand and China. Major buildings such as Mahamuni Pagoda, Ananda Pagoda and several others were significantly damaged.
