Earthquake in Myanmar

Earthquake Impact Map of Sagaing City

Observed on 29/03/2025

Charter Call 1095

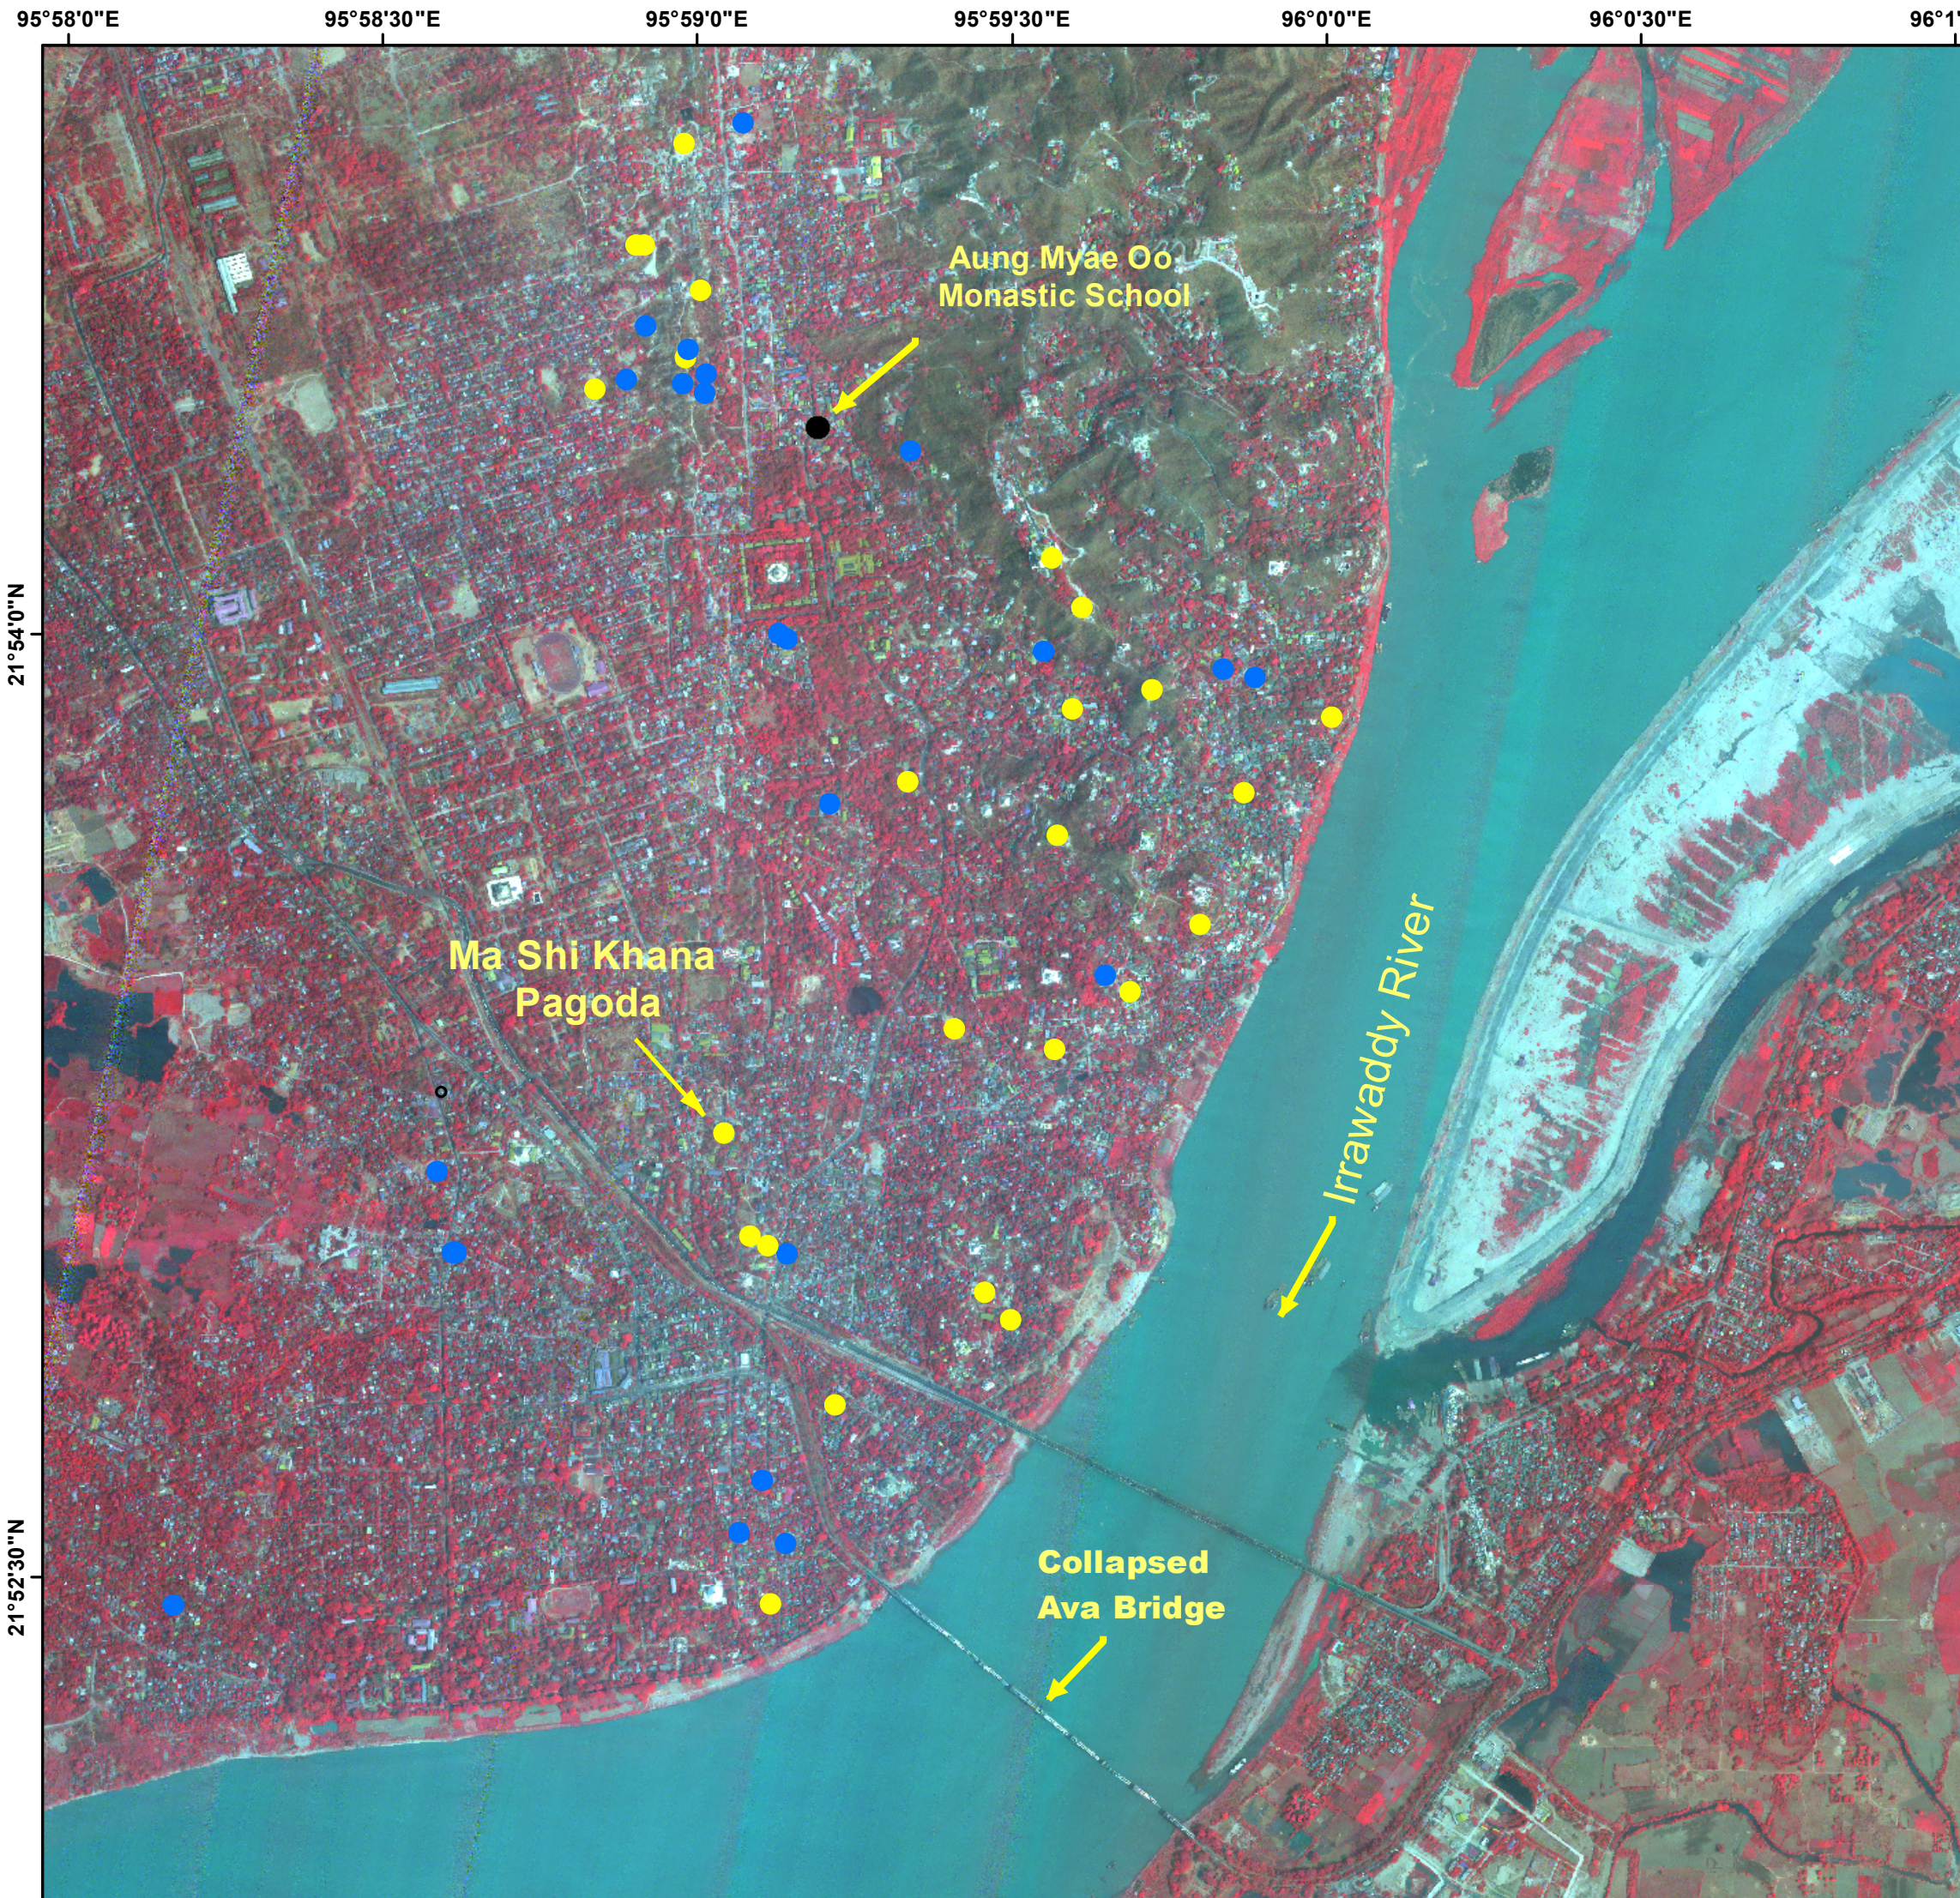
AOI No.01

- Damaged Monasteries
- Damaged Buildings

An earthquake of magnitude 7.7 struck near Sagaing, Myanmar on 28 March 2025 06:20:54 (UTC) followed by atleast three strong aftershocks. The tremors was also felt intensively in India, Bangladesh, Laos, Thailand and China.

This map shows the possible locations of damaged building and monasteries in the Sagaing City of Myanmar
