Flood Inundated areas in Part of Telangana State

Based on the analysis of RISAT-1A SAR data of 20-August-2022 (0600 Hrs)

DISASTER EVENT ID-8: FLD-2022-TS
MAP ID: 2022/11/Ver.1

Date of Issue : 20.08.2022

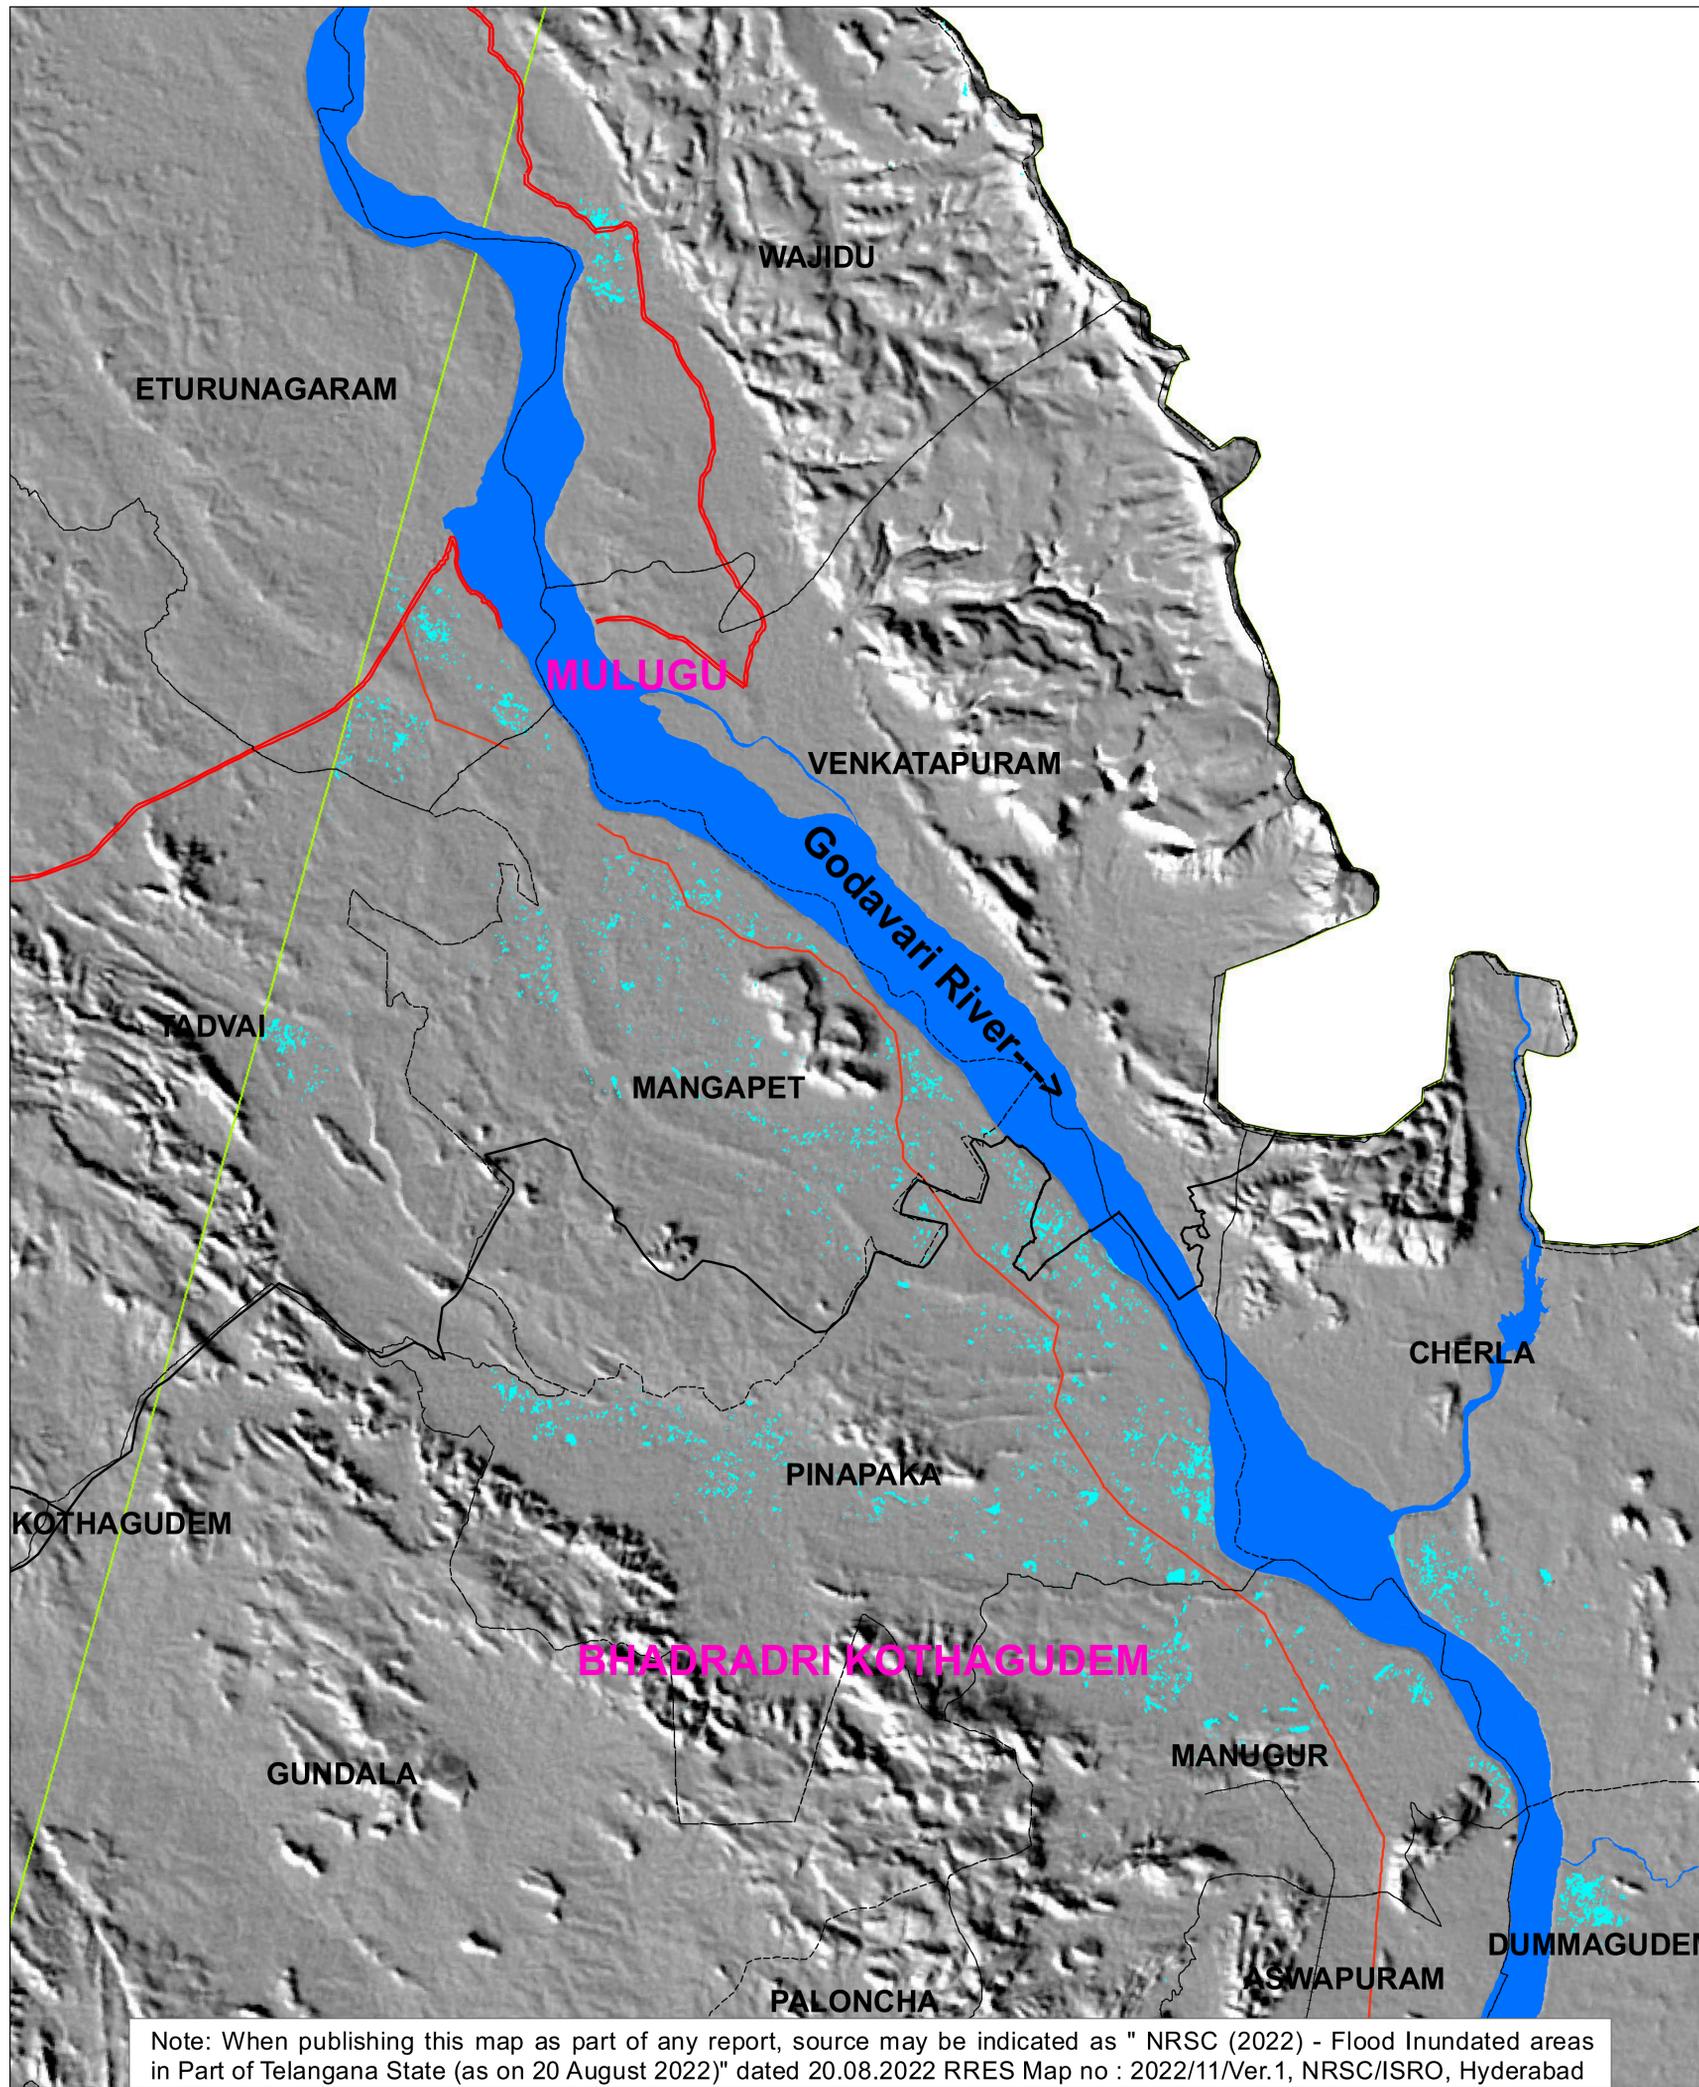
This map highlights the flood inundation in 2 districts of Telangana State as on 20 August 2022.

Flood inundation may include rain water accumulation / flood water in low lying areas.
