Heavy Rain Affected Areas in Parts of Belgaum, Karnataka

DISASTER EVENT ID: 09-FL-2021-KA
MAP ID: 2021/01

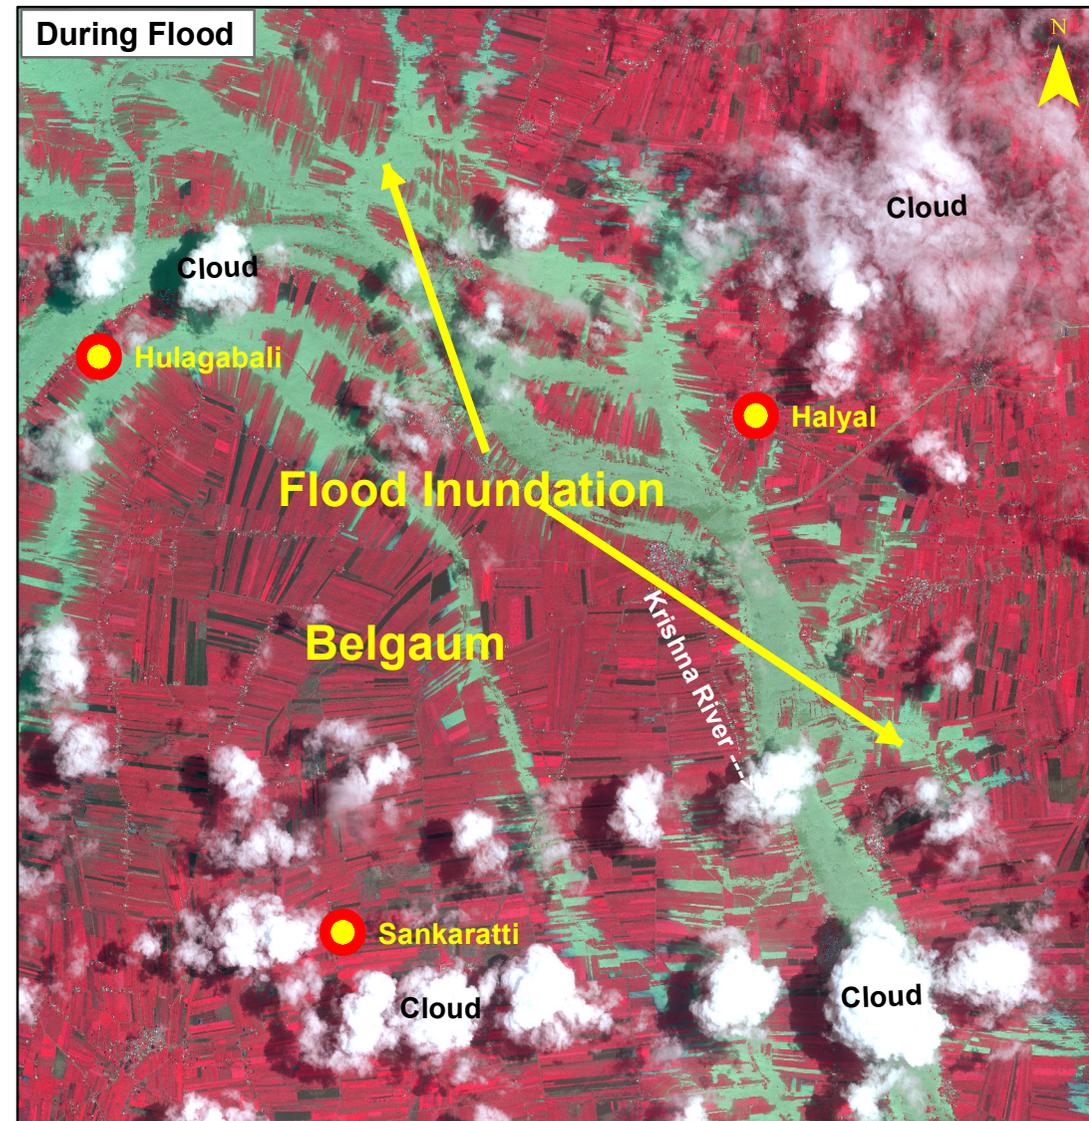
WorldView-3 Image of 26-July-2021

Heavy incessant rains lashed Karnataka state during the fourth week of July, 2021. Rivers Ghatprabha and Dudhganga were reported to be flowing in severe flood situation. Belgaum district was reeling under floods. WorldView-3 Image obtained showcases the flood inundated areas in the State.
