Flood affected areas in ANDHRA PRADESH State during Michaung Cyclone

Satellite Images showing Post Cyclone Scenario as on 7-12-2023

-- Parts of Tirupati District

Map ID: 2023/CY/AP/9h/07122023

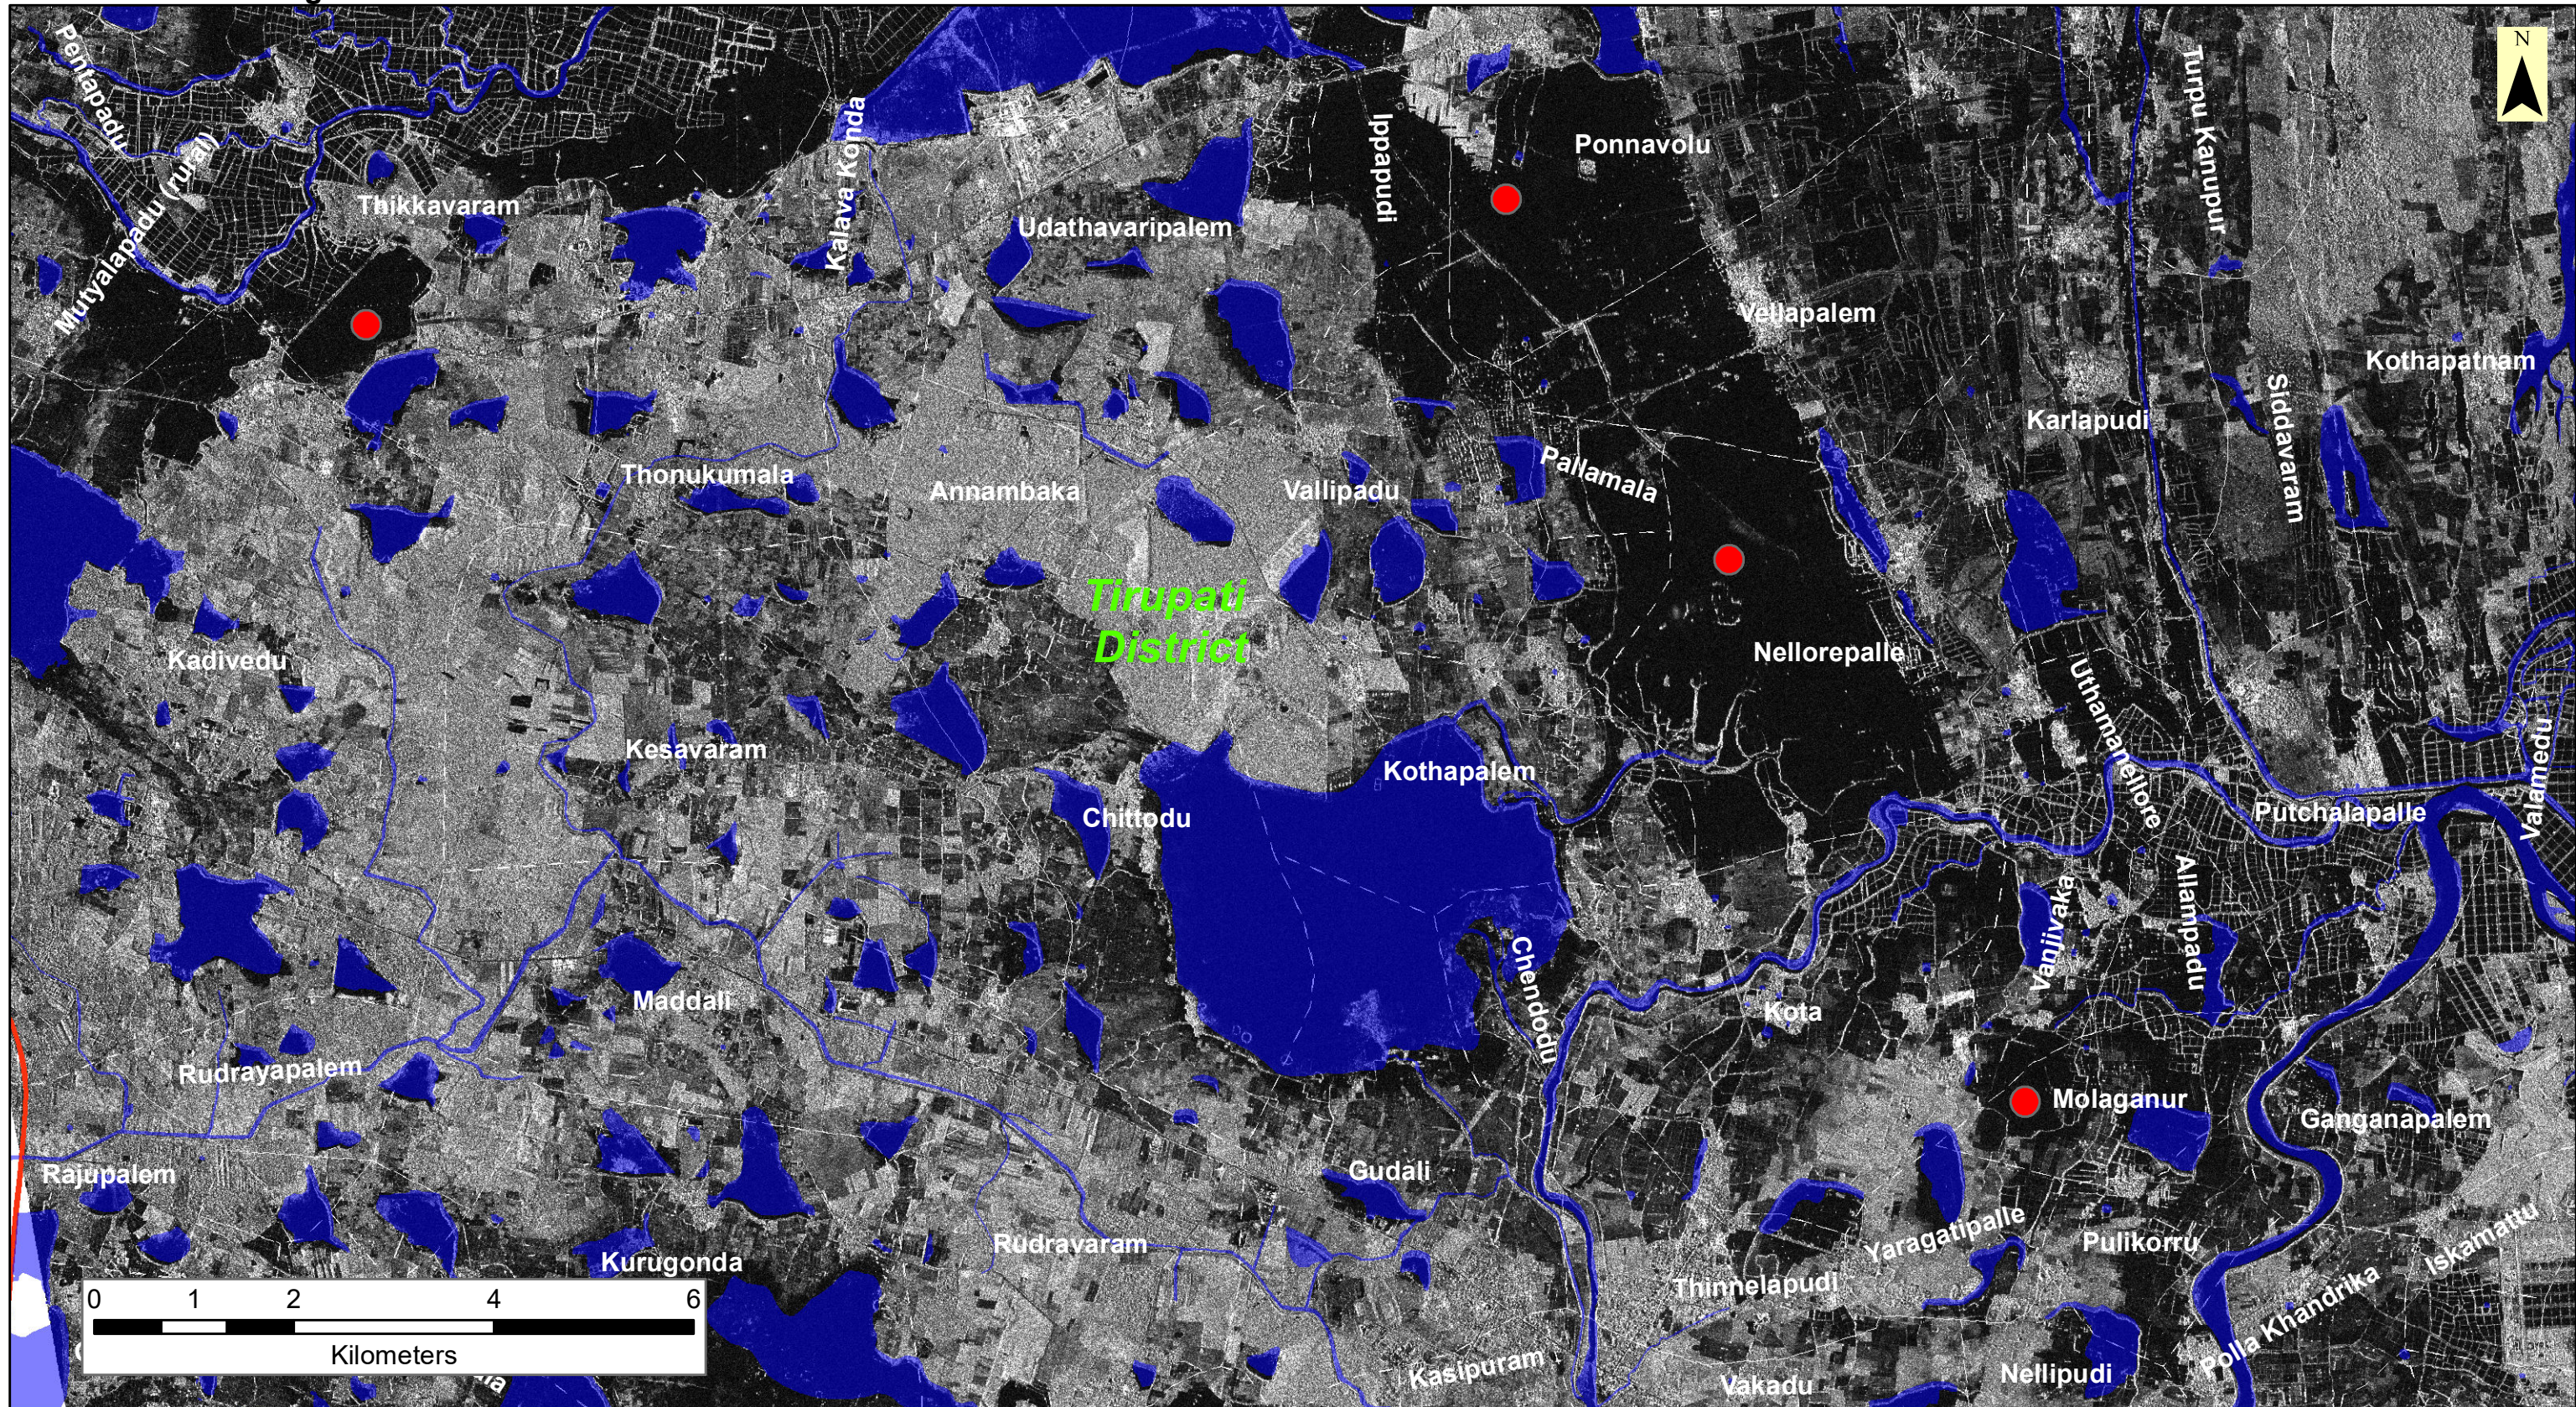
RISAT-1A FRS image of 7 Dec 2023

● Note : High Resolution (3m) RISAT-1A FRS SAR Image of 07, Dec 2023 (1800Hrs) indicate that there are several villages with standing water (deep black clour in the above image). This may include water in crop fileds / standing water in low lying areas / Areas where flood is just receded . Village names are provided for local value addition of this information . Blue colour indicates normal reference water bodies / river/ stream before the flood event.

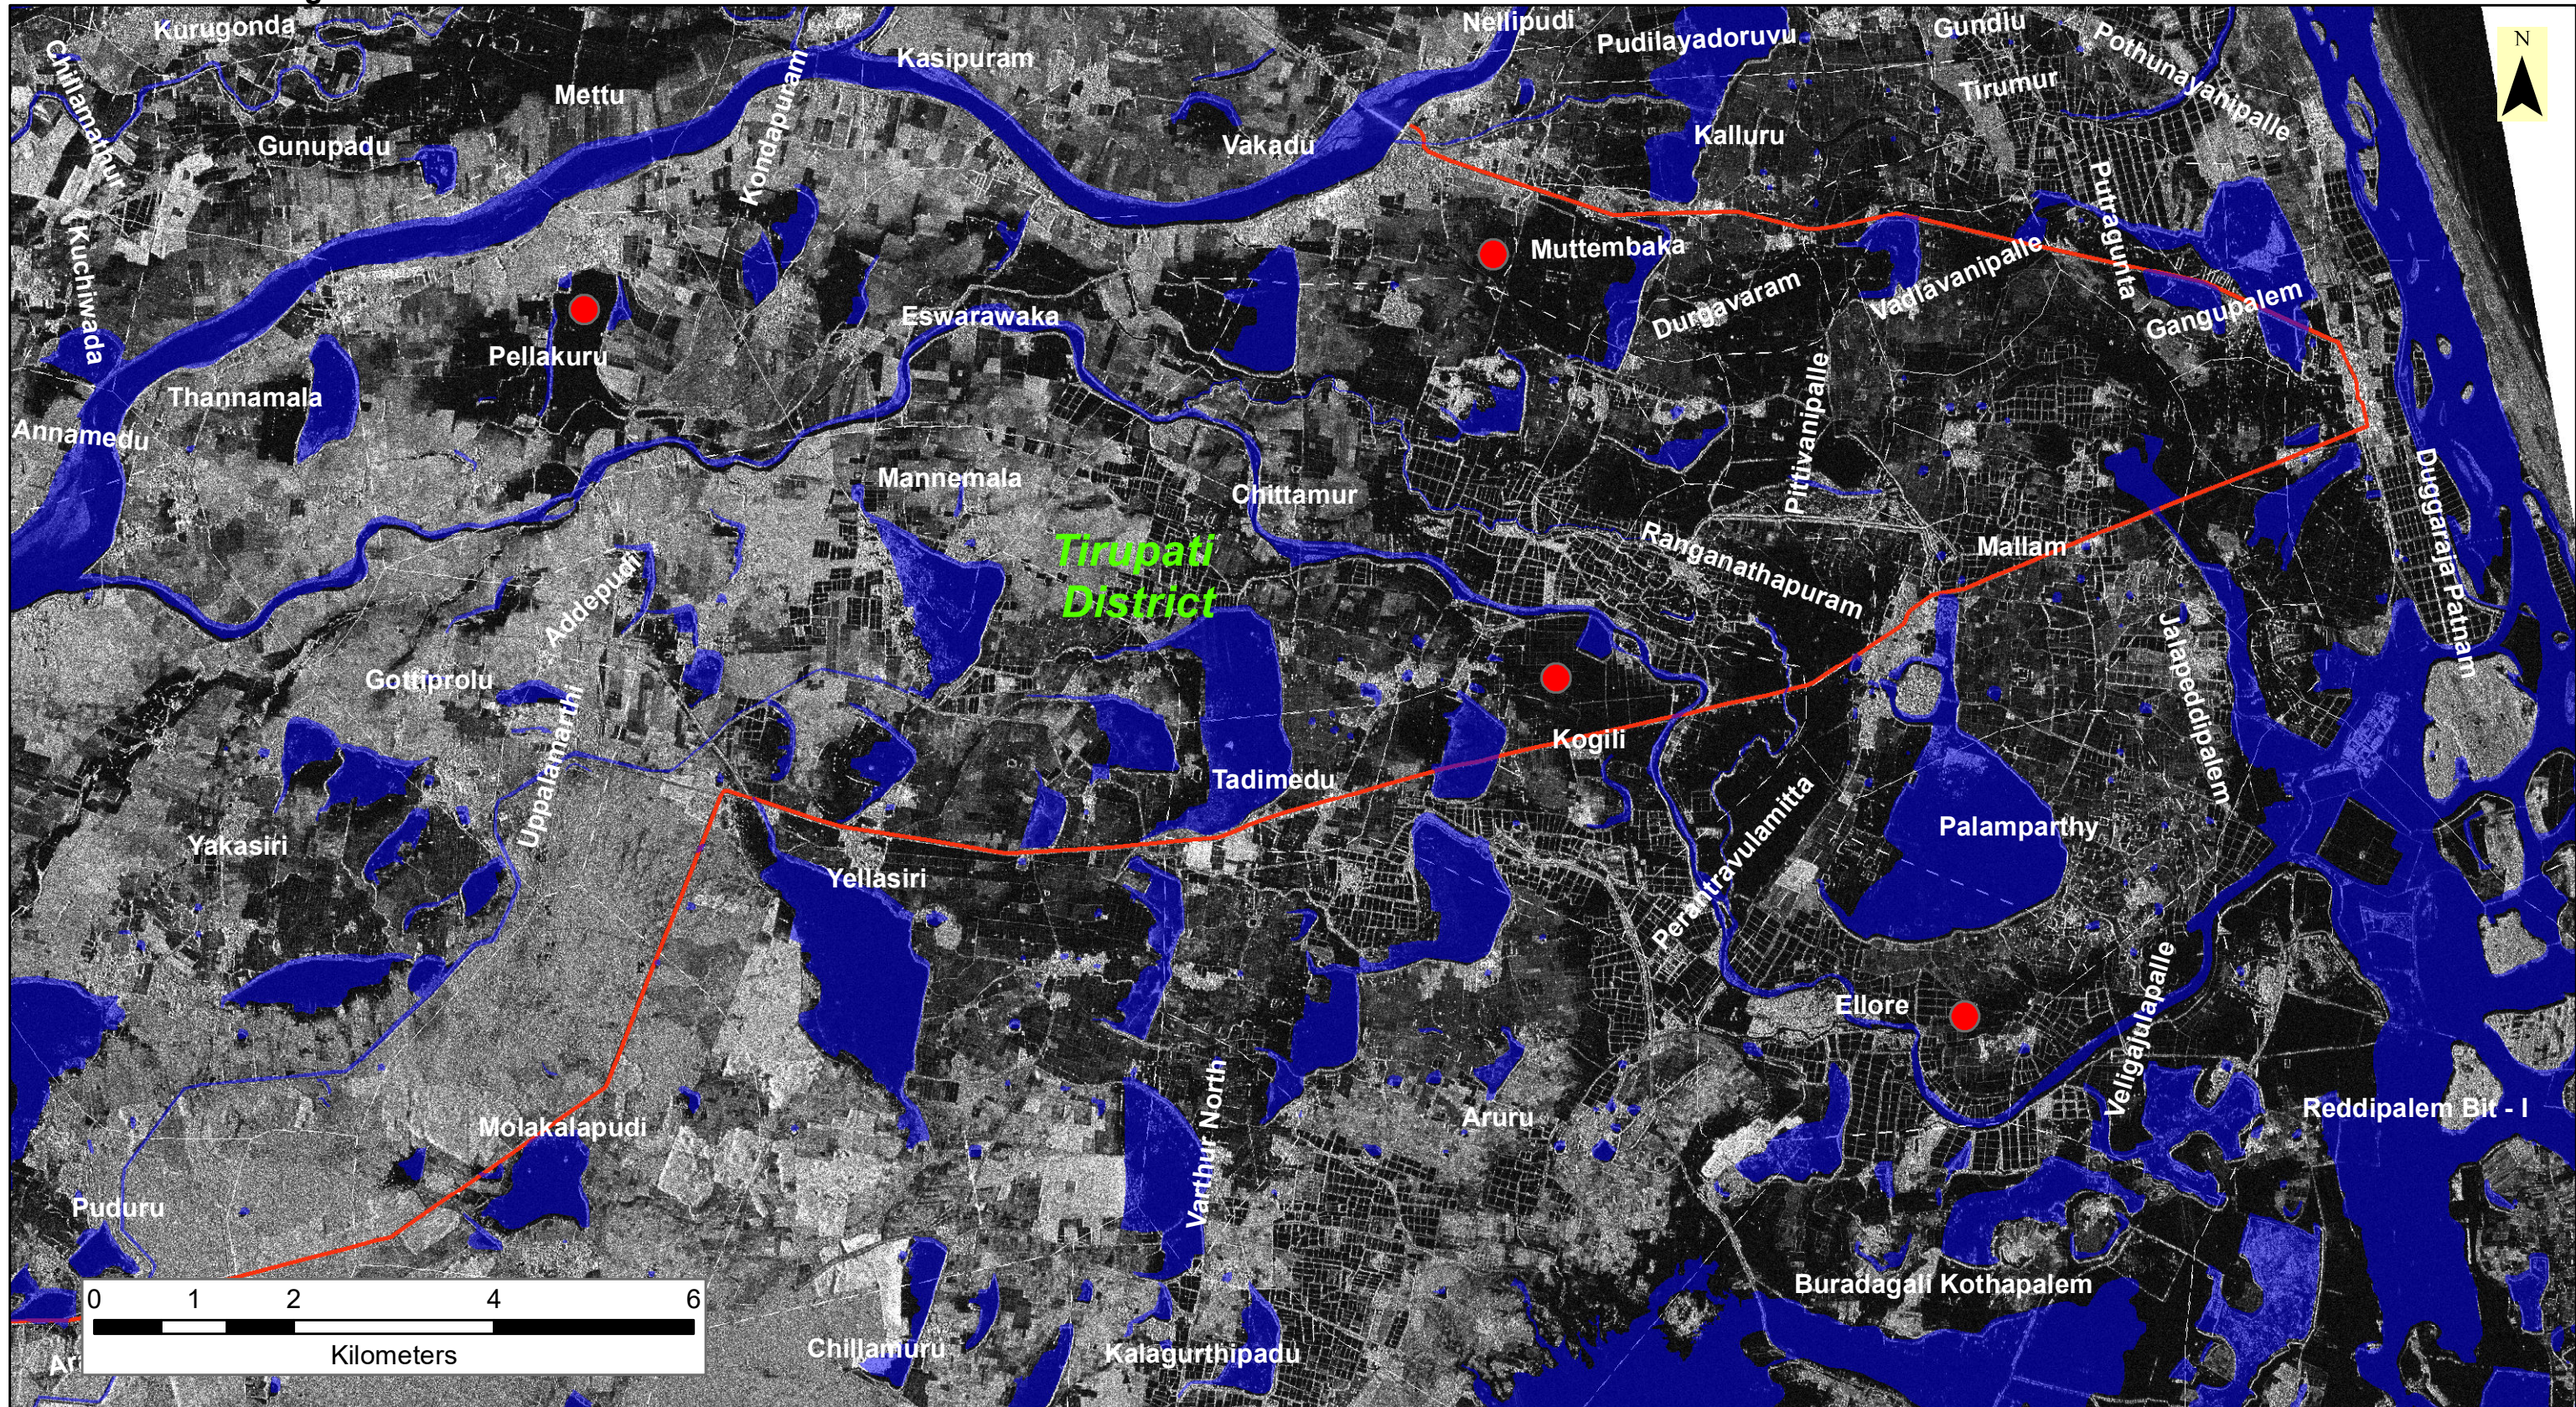
RISAT-1A FRS image of 7 Dec 2023

● Note : High Resolution (3m) RISAT-1A FRS SAR Image of 07, Dec 2023 (1800Hrs) indicate that there are several villages with standing water (deep black clour in the above image). This may include water in crop fileds / standing water in low lying areas / Areas where flood is just receded . Village names are provided for local value addition of this information . Blue colour indicates normal reference water bodies / river/ stream before the flood event.
