Heavy Rain Inundated areas in part of Bihar State

Based on the analysis of Radarsat-2 SAR Image of 27-June-2020 (0600 Hrs)

DISASTER EVENT ID: 03-FLD-2020-BR
MAP ID: 2020/04

Date of Issue : 27.06.2020

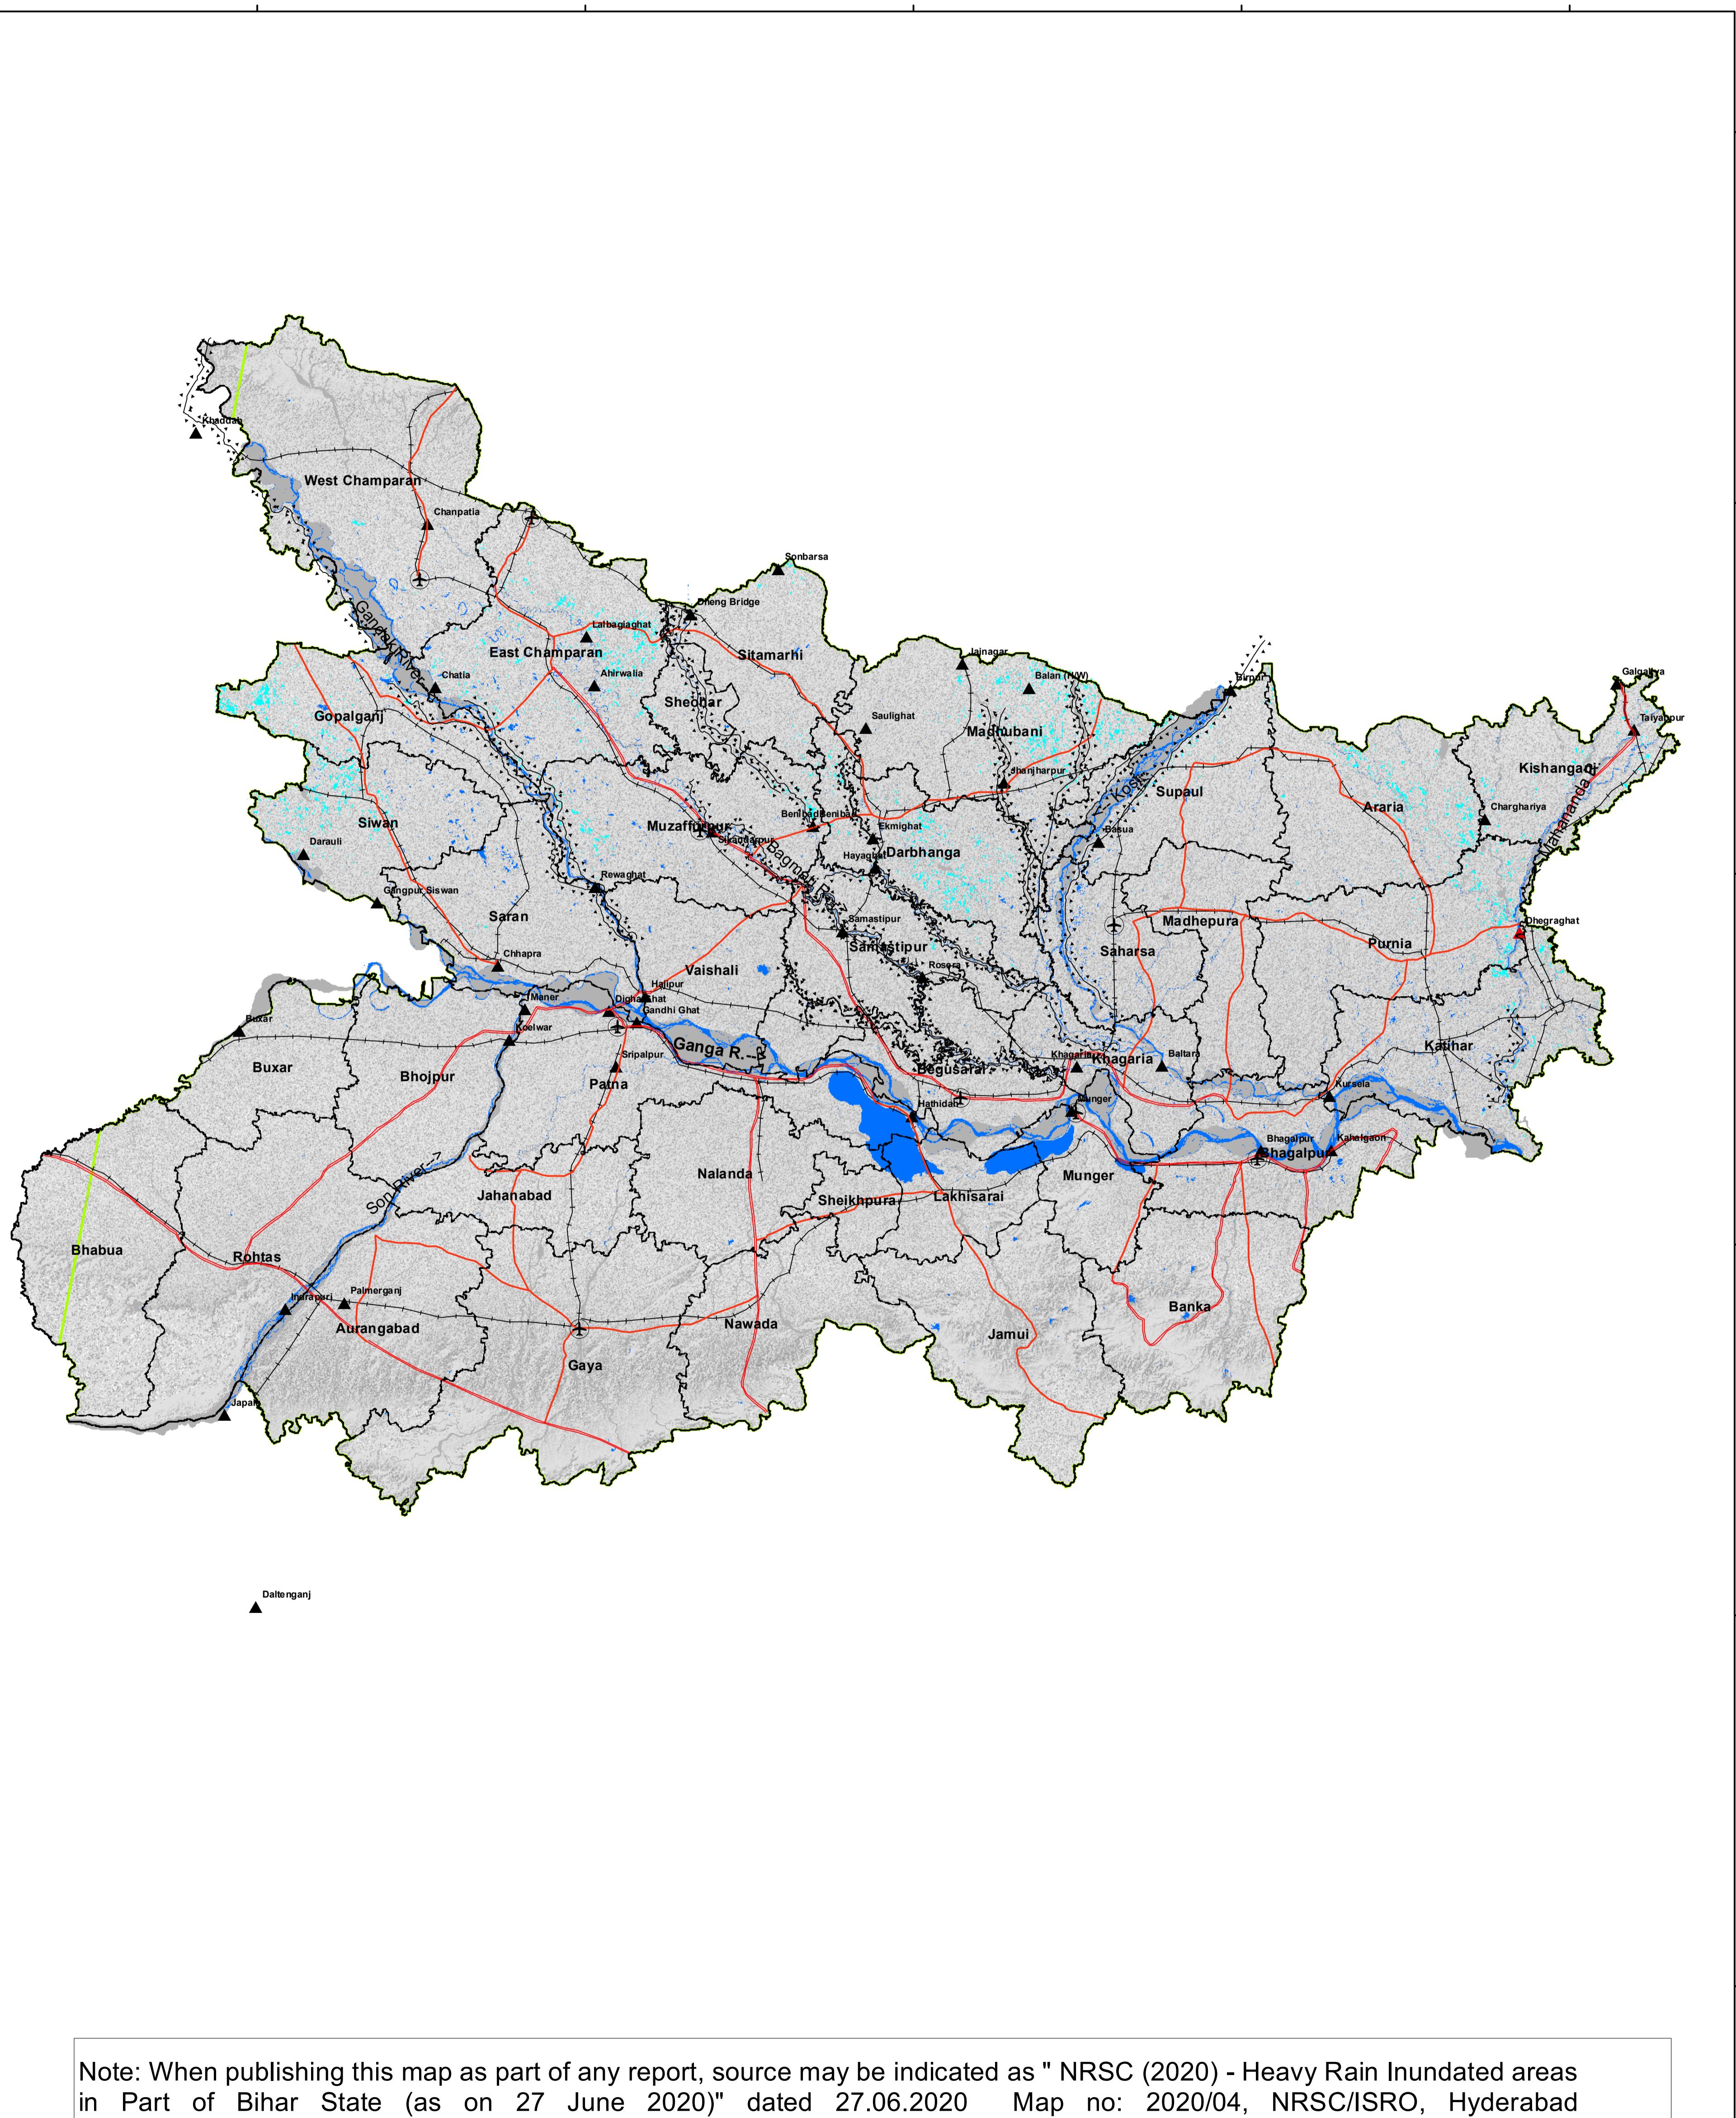
Heavy rains are reported in Bihar during fourth week of June 2020 and caused steady rise in water levels in parts of Bihar state. According to reports, River Parman and Mahananda were reported to be flowing above danger level. (Source: News Media, FMISC)

This map highlights the inundated areas due to heavy rains in 11 districts of Bihar State as on 27 th June 2020 (0600 Hrs).
